NASA TN D-3070

OPERATIONAL AND PERFORMANCE CHARACTERISTICS OF THE X-15 SPHERICAL, HYPERSONIC FLOW-DIRECTION SENSOR

by Chester H. Wolowicz and Terrence D. Gossett

Flight Research Center
Edwards, Calif.

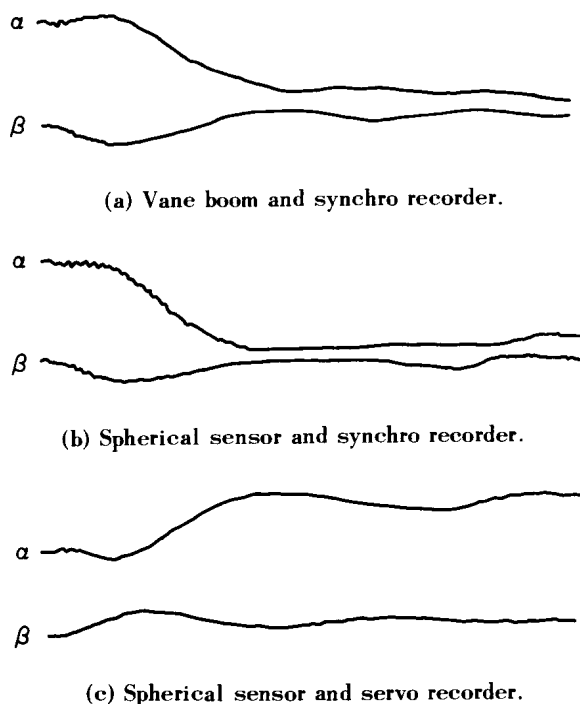
Recorder feedback effects.— Initially, the synchro transmitters of the sensor were coupled with synchro receivers for the purpose of recording data, as were the vane-boom synchro transmitters previously used. However, within the spherical sensor, a portion of the signal from the synchro transmitters is used for degenerative feedback, thus lowering the gain of the α and β inner-positional servo loops. This feedback-utilization technique is basically stable but causes instabilities in the sensor servomechanism when used with a recorder of the synchro-receiver type. The problem arises from the excited rotor contained within the synchro receiver, which acts as a transmitter when

Figure 5.— Relative time histories of sensor systems equipped with synchro recorder and servo recorder.

used as described. The problem was solved by replacing the synchro recorder with a servo recorder which incorporates a passive rotor. Figures 5(a) to 5(c) show comparative time histories of the vane-boom and spherical sensors equipped with synchro receiver recorders and the spherical sensor equipped with a recorder which has a passive rotor driven to null (servo recorder). This figure indicates that the spherical sensor oscillates when it is used with a synchro receiver recorder and that the oscillation is minimized when a servo recorder is used.

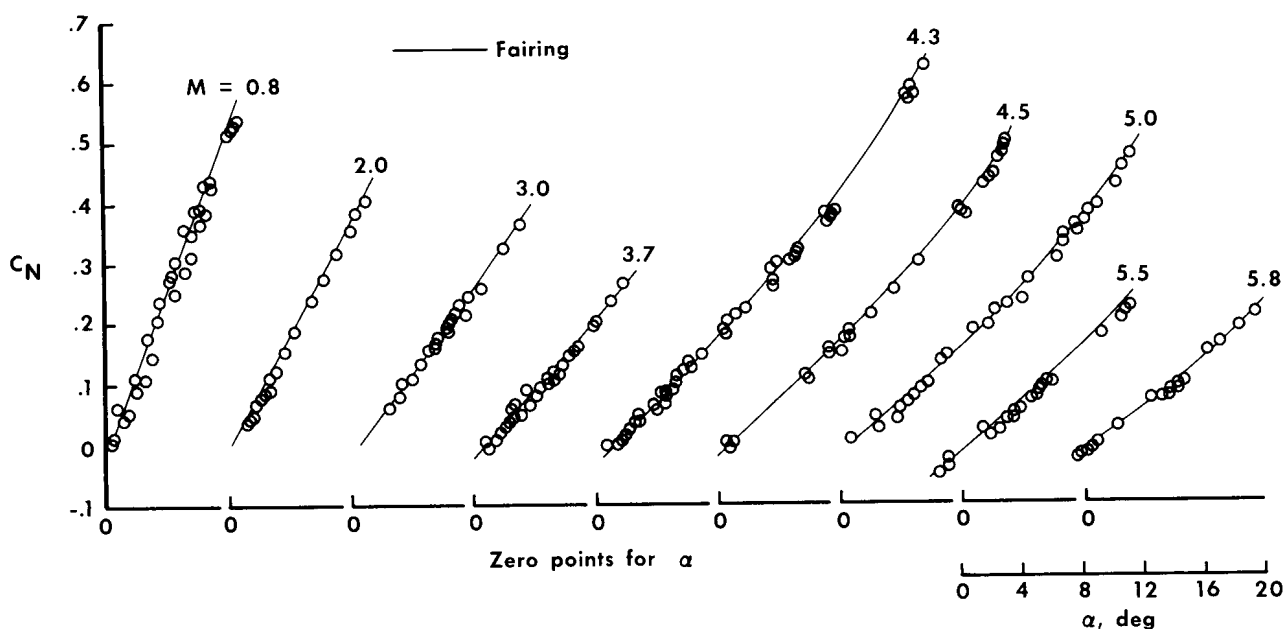
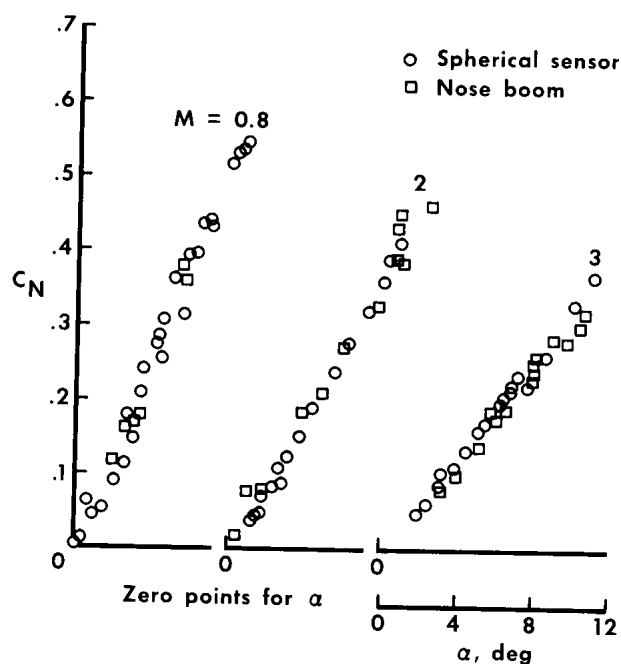
Figure 8.— Comparison of variation of normal-force coefficient with angle of attack measured in flight by spherical sensor and with nose-boom α-vane. Speed brakes closed; $q > 20$ lb/sq ft.

A comparison of the variation in flight-determined C_N with α determined by the spherical sensor and by the nose-boom α-vane at Mach numbers of 0.8, 2.0, and 3.0 is shown in figure 8. The figure shows good correlation of the data. Inasmuch as the synchro transmitter and receiver of the boom-mounted α-vane sensor have manufacturer's quoted accuracies of ±0.5° and are the least-accurate portion of the vane-boom system, it may be assumed, on the basis of the comparisons in figure 8, that the angle-of-attack portion of the spherical sensor also has this, or better, accuracy up to $M = 3.0$.

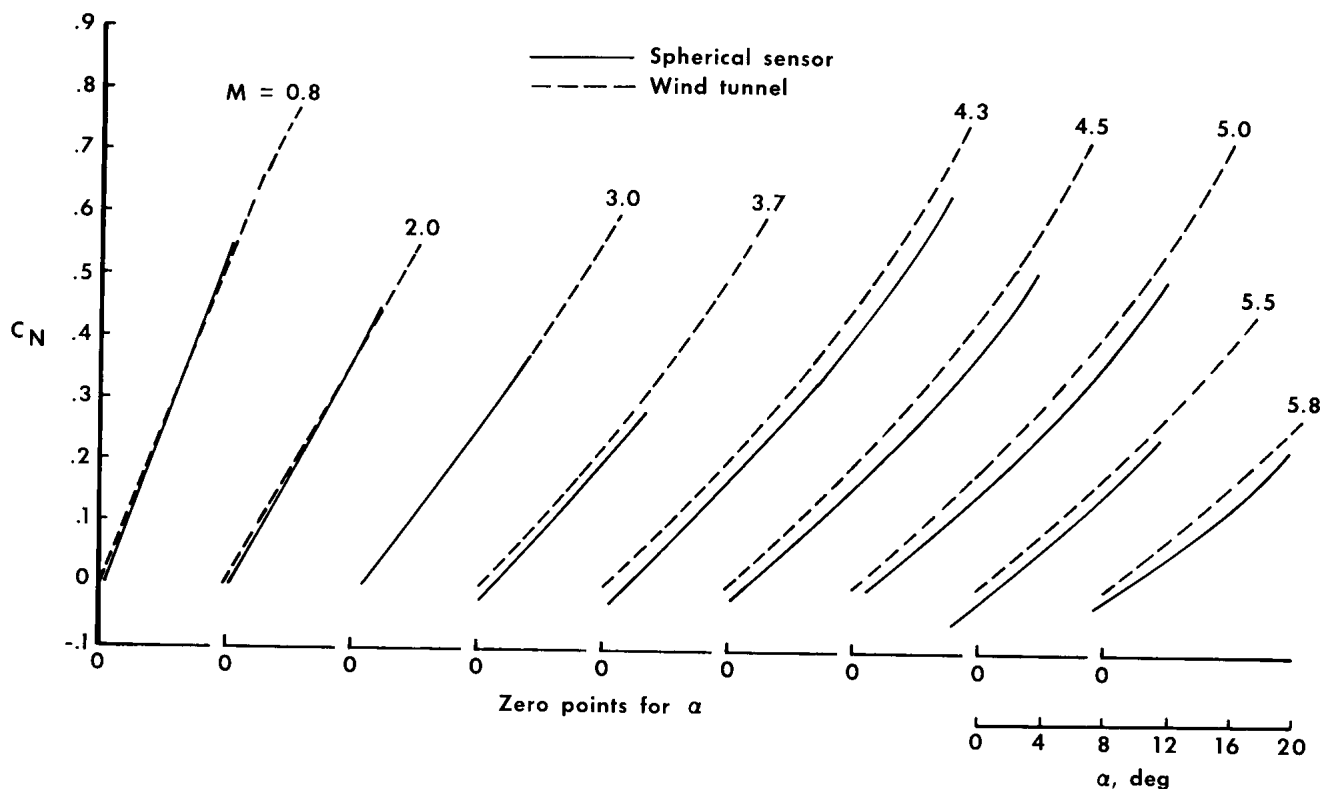
Figure 9.— Comparison of variation of normal-force coefficient with angle of attack of spherical-sensor flight data with wind-tunnel data. Speed brakes closed; $q > 20$ lb/sq ft.

sensor with faired wind-tunnel data obtained with X-15 models shows good corre-
lation of the slopes of C_N versus α at all Mach numbers. For Mach numbers
at and below M = 3.0, the absolute values of the data are in good agreement;
however, at higher Mach numbers a discrepancy of about 1° to 1.5° exists be-
tween the flight and wind-tunnel angles of attack for given values of C_N.
Although complete correlation is not expected, the fact that the data agreed
well at and below M = 3.0 but showed a discrepancy at higher Mach numbers is
difficult to explain. Some of the discrepancy may lie in the fact that wind-
tunnel data were taken from faired measured data obtained in several facilities
(ref. 5). In addition, the aircraft is not an absolutely rigid structure, and
the flight data were obtained from various types of maneuvers.

All factors considered, the spherical sensor is believed to be inherently
accurate to better than ±0.5° within the angle-of-attack range of the flight
data shown in figure 9, that is, up to approximately 22° at dynamic pressures
above 20 lb/sq ft.

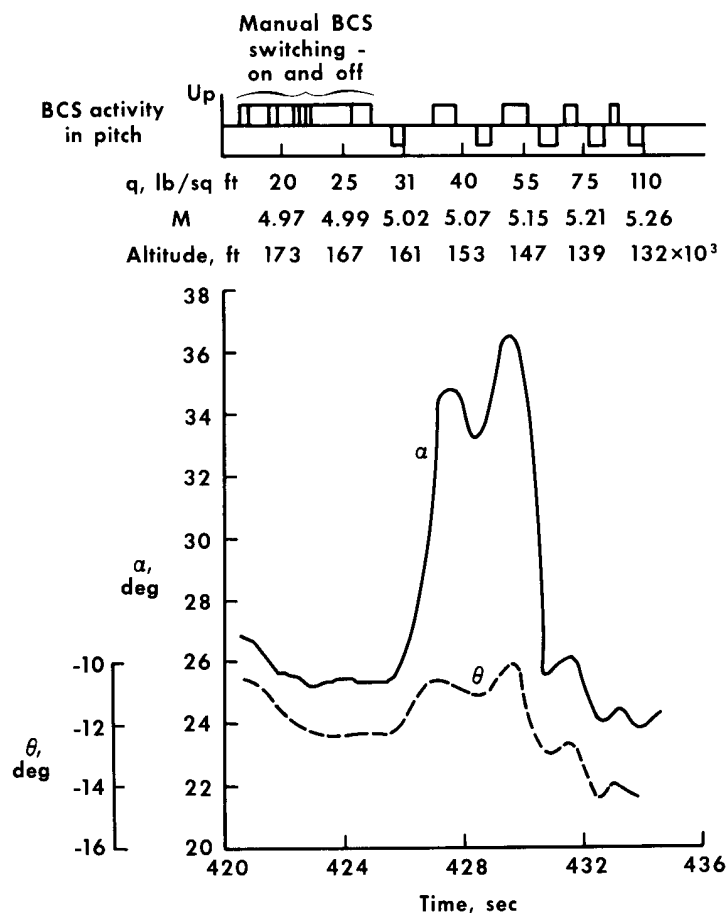
During reentry from high altitude, the X-15 airplane, in addition to
experiencing low dynamic pressures, occasionally undergoes high-angle-of-attack
conditions of the order of 26°
and higher. Records typified by
the traces in figures 10 and 11
appear to indicate that the
sensor system will sometimes
provide erroneous angular indi-
cations when the angle of
attack is higher than approxi-
mately 26° and dynamic pressure
is less than approximately
40 lb/sq ft. Figure 10 shows
that the indicated angle of
attack flared from approxi-
mately 26° to 36° during re-
entry in the dynamic-pressure
region of approximately
31 lb/sq ft to 60 lb/sq ft.
This flaring is not in agree-
ment with the magnitude of
pitch-attitude changes shown,
inasmuch as the flight-path
angle (equal to $\theta - \alpha$ for a
wings-level condition) changes
slowly in this portion of the
reentry. Since the reaction
control system in pitch was ac-
tive during the initial phase

of this flareup as well as
during the portion shown in
figure 10, it may have been a
strong factor in inducing the
flareup. Figure 11 shows, how-

Figure 10.— Time history of flareup in angle-of-attack indications
of spherical sensor during reentry. Ballistic control system

(BCS) active in pitch only.

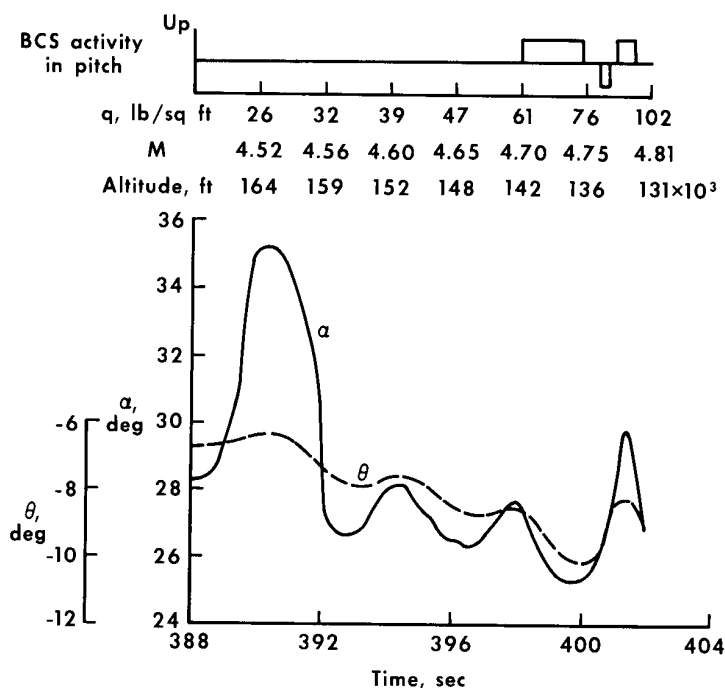
Figure 11.— Time history of flareup in angle-of-attack indications of spherical sensor during reentry. Ballistic control system (BCS) inactive during flareup.

occurred in the absence of the reaction-control activity under similar situations when the preflare angle of attack was approximately 28°. A possible incipient tendency toward flareup is shown in figure 12 at approximately 433.5 seconds at $\alpha = 24°$; however, reaction-control activity in pitch to increase negative pitch attitude at 436.5 seconds appears to have countered the tendency. Although the specific causes of this phenomenon are not positively identified, it appears that the lip of the collar of the sphere housing may be causing flow interference that affects the angle-of-attack port nearest the collar and, thus, results in a flareup in the angle-of-attack indications. This tendency may be compounded by the dynamic-pressure rate limitations of the sensor's gain-compensation system (potentiometer wiper lag).

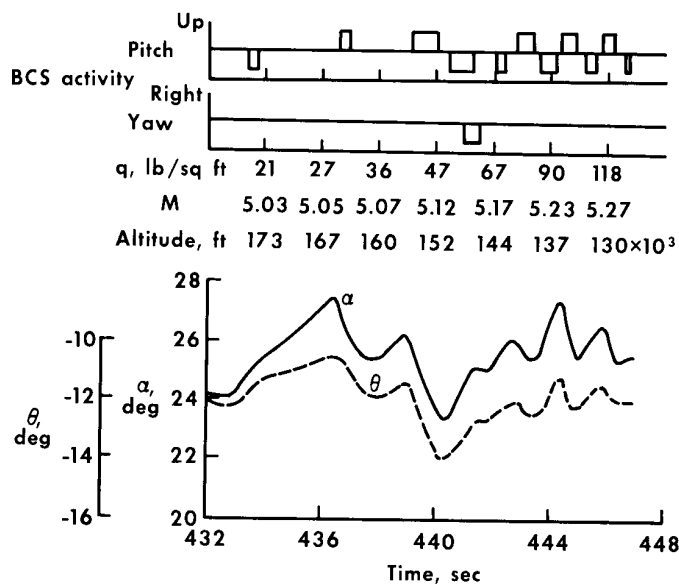
Figure 12.— Time history of angle-of-attack indications of spherical sensor during reentry showing incipient tendency toward flareup at approximately 433.5 seconds at $\alpha \approx 24°$.

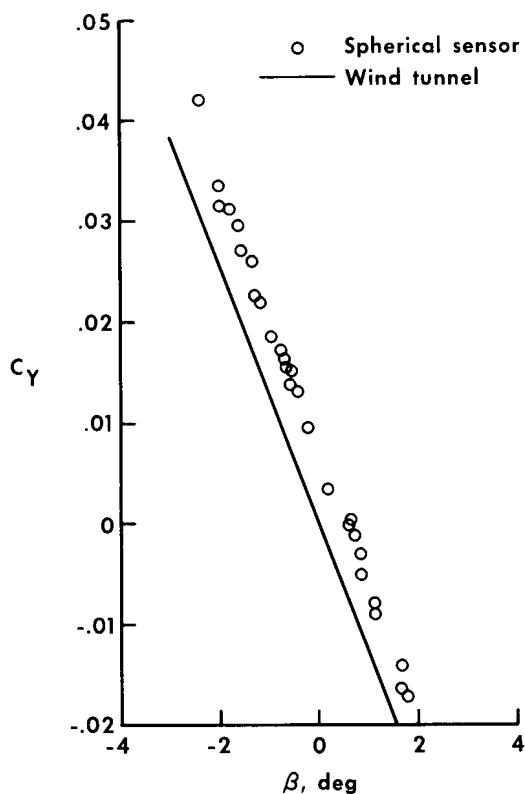
Figure 15.— Comparison of wind-tunnel and flight-determined variation of side-force coefficient with angle of sideslip. $M = 5.0$; $a = 2.1°$; $q \approx 670$ lb/sq ft.

Angle-of-sideslip measurements.— The characteristics of the spherical sensor for sideslip-angle indications are represented in figure 15 by the variation of the side-force coefficient with sideslip angle for a nominal Mach number of 5.0 at a nominal dynamic pressure of 670 lb/sq ft and an angle of attack of 2.1°. The consistency of the flight data, obtained from several flights, appears to be good. The faired curve of wind-tunnel data is included for comparison. The slopes correlate well; however, a discrepancy of about 0.5° exists in absolute values. This discrepancy may be attributable to the factors mentioned for the angle-of-attack comparison, as well as to possible misalinement of the sensor with the airplane axis and a possible slight asymmetry in the airplane. Probable sensor-housing lip-interference effects are not a problem in sensing angle of sideslip because of the small sideslip excursions of the airplane.
